## Some technical and maintenance issues regarding the IC-781 and IC-R9000

by Traian Belinas, YO9FZS

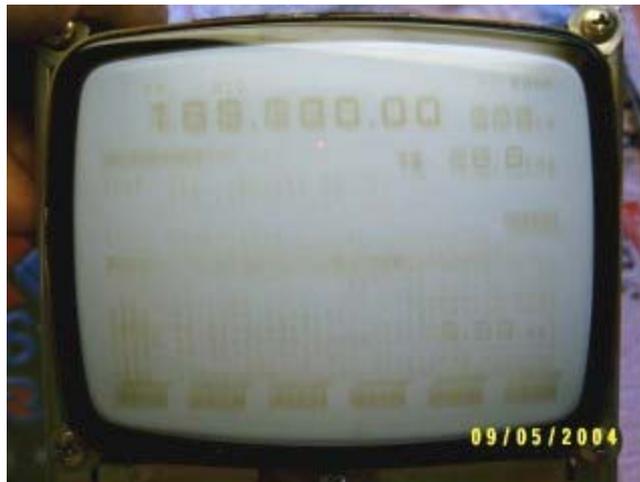
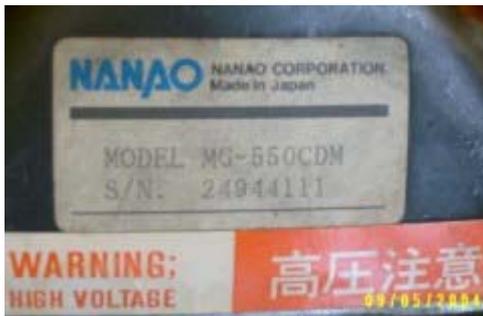
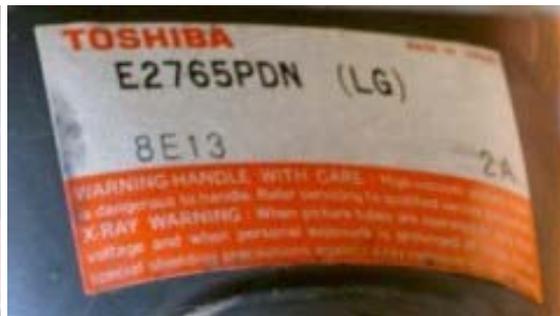
It is as if the picture pattern has been "imprinted" on the CRT screen. For the affected areas, the picture brightness and CRT phosphor efficiency is lower.

**This is permanent damage and cannot be corrected or avoided, but fortunately this kind of problem is not really catastrophic – this type of CRT may still function for many years after the first visible appearance of the burns, even if it may be uncomfortable to some. If needed, an external video monitor accepting NTSC CVBS input may be also used (or NTSC TV).**

You may see below how these burns may look; this example is from an IC-R9000.

The CRT below had maybe 10 years of use, most at a government agency before I got it (so it may had intensive use), and even now after I have sold it, it is still functioning at the new owner's QTH without these burns causing much trouble. This is also because the CRT itself is a relatively good quality one made by Toshiba. The CRT module is made by Nanao.

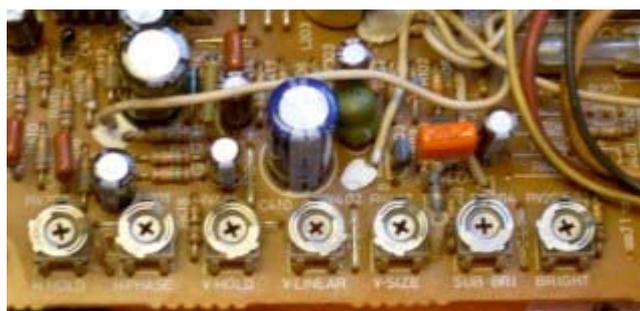
The low brightness of the old used CRT’s may be improved by using the internal adjustments of the CRT module. You have to open the CRT module top cover to gain access to them. To do this, you need to open the transceiver case, then to take out the six screws holding the CRT module top cover. The ATU preset pots PCB must also be removed. These adjustments are located on the CRT module PCB, close to its right side:

**SUB-BRI and BRIGHT** are the ones adjusting the brightness of the picture; adjusting them CW will increase the brightness of the CRT displayed picture.

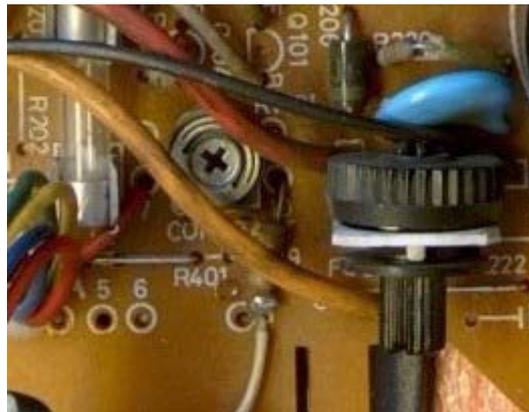
Contrast and Focus adjustments

**If the CRT picture is dim**, try to adjust the Contrast pot first, and then the Brightness pots. When adjusting them, do not exaggerate. Don't set so high that the background (normally black) becomes very bright/amber, because using it in this way for a long time will shorten the CRT life (as explained previously), and the very high contrast may tend to a faster appearance of the burns on the screen.

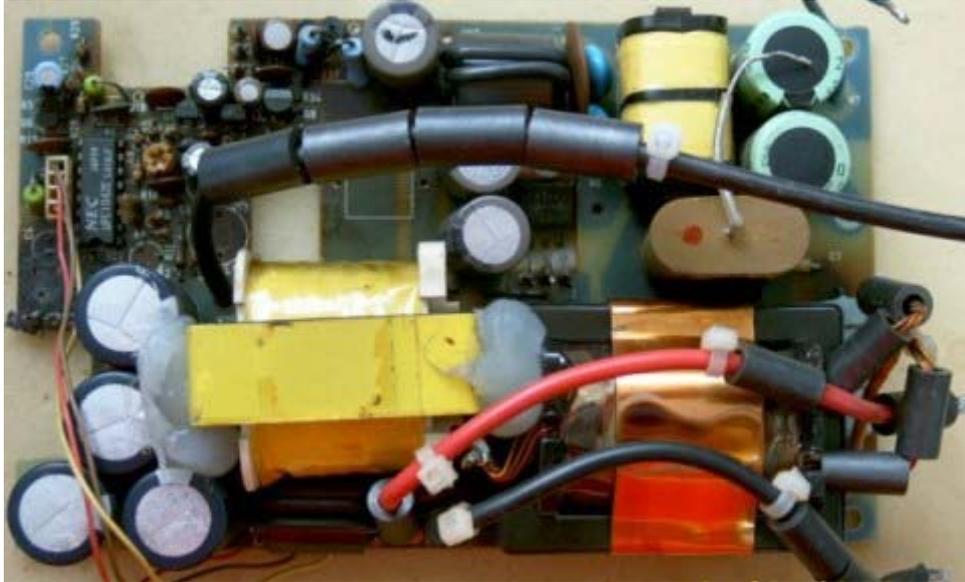
This is why overheating may damage the REG PCB, and the PCB itself may present burned areas and/or burned PCB traces, especially in the area close to R32 and Q7. Power resistor R32 can dissipate its rated power at 25°C, but not at 70°C... This overheating may also affect the electrolytic capacitors and even other small parts close to them. Special attention needs to be paid to potentiometer R2, which is included in the switching supply feedback loop. If R2 goes open or is damaged, it may cause output overvoltage, with possibly harmful consequences.

The REG PCB with most of the original parts on it;  
A few of the overheated parts near R32 area were already removed.

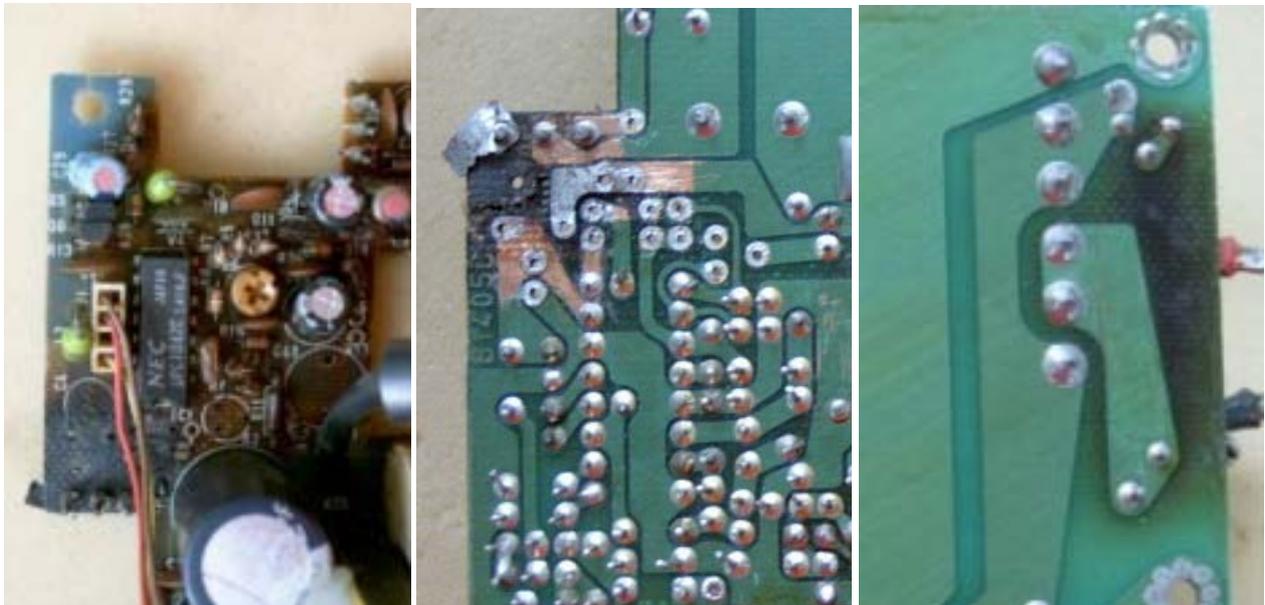
Burned PCB and copper traces near the R32, Q7 and R26; some parts are missing here.

Don't hesitate to make use of better and more trustworthy spare parts, it is not necessary to look for the 20-year-old “authentic originals”. I have found Q7 shorted and R32 interrupted and overheated. The 2SD1406 used for Q7 has 20W dissipation and maximum collector current 3A. I have used a 70W 8A TIP132 Darlington and insulating mica foil instead of the 2SD1906. [Don't use much higher current/power bipolar transistors as they usually have very low amplification (beta) and D5 may not withstand the higher base current required]. Don't forget to use thermal compound, insulating washers and mica foil where needed (D2, D3, Q2, Q3). Before assembling the PCB you may check the uPC1042 IC (it has to start oscillating) and verify the +9V and +5V regulator functionality after connecting an external current-limited 15V PS at C13 (observe polarity). Re-install the PCB inside its compartment only if all of these are OK. As a precaution, you may insert a 3.15A fuse in the 280V line (you may also leave it in circuit).

- Restore the PCB's circuit connections as needed, using the terminals of the newly installed parts if required;
- Check and if needed replace Q7, R32, D5, R2;
- Replace the small electrolytics with new high-quality parts; these must be rated for 105°C;
- If any sign of damage is visible at the C8, C9, C13, C15, C16, C20 to C23 (electrolytics), these may be replaced if spares are available - use the highest quality parts obtainable. Remember that the power supply must deliver 500W DC output and the caps must also be of 105°C type.

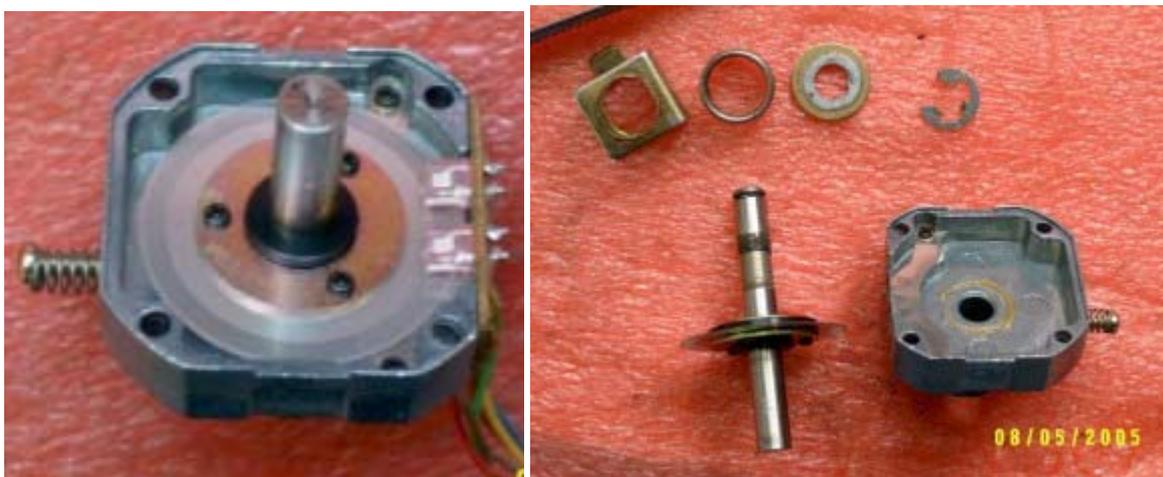
For both radios the VFO encoder knob had been rotating with some difficulty, even when its adjustable brake was released. This was caused by the old grease used in the shaft bearing. This grease has solidified because of age. It is inadvisable to use the radio with a stiff encoder shaft for any length of time, as this will cause a rapidly increasing backlash.

Clean the dirty shaft and the sleeve bearing remove the existing grease using isopropyl alcohol and then re-lubricate shaft and bearing. To reduce any backlash, lubricate with grease rather than oil. Don't use much grease; a small quantity will suffice. Avoid getting lubricant on the optical parts;

clean them if needed. Also lubricate the small Teflon and metallic washers and take care when reassembling the encoder. The lubricated encoder will rotate easily and will feel like a new one.

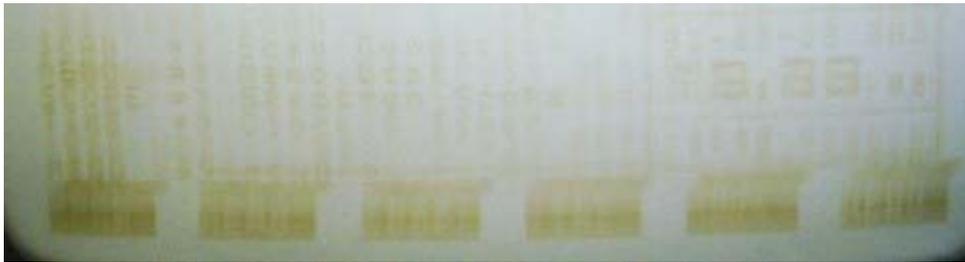
Over time, the image may become distorted, with the vertical lines bent and the picture shifted to the right side for some areas, especially for the larger bright areas of the picture. This occurred in both radios I had; it seems that the R9000 was presenting this behavior for a long time before acquired it, as the distorted image became permanent because of the CRT burns. Just look below for burns on the CRT's bottom edge; see how the upper parts of the highlighted menu labels were shifted to the right side, and the normal rectangular menu labels became similar to a flag, as if caused by a horizontal sync problem...

The cause of the problem was C11, a 100uF electrolytic on the CRTC module. C11 had to be replaced.

As the CRTC module is hard to remove from the Digital board, I had to cut/extract the body of C11 while leaving its terminals still attached to the PCB. Then carefully free its terminals from the PCB by heating them with a soldering iron from the component side. I have used a small 100uF cap (a slightly larger value one will do also) which was installed horizontally over the passive components near IC2, with its terminals bent down and soldered at the original C11 holes from the more accessible component side of the PCB. This avoided the need for removing the entire CRTC module, a difficult and time-consuming exercise. Don't forget - use a good quality capacitor and you may not have any further problems in this area.

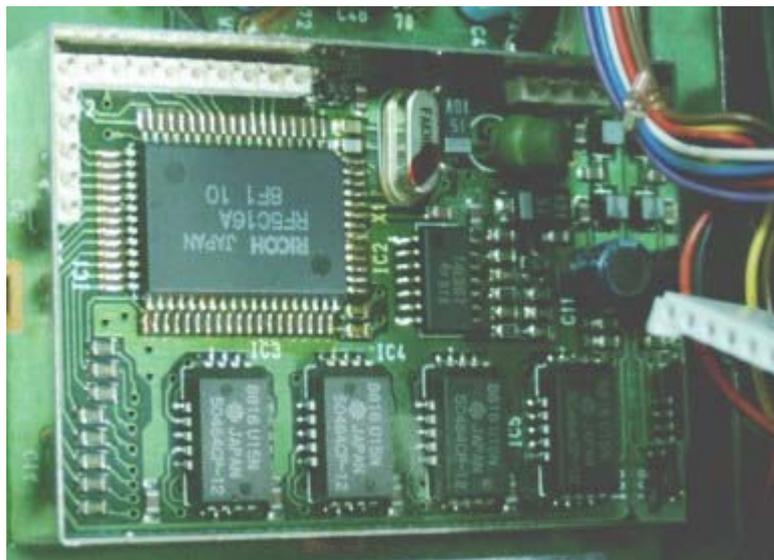
The opened CRTC module;  
C11 is the blue cap, to the right of the CRTC module.

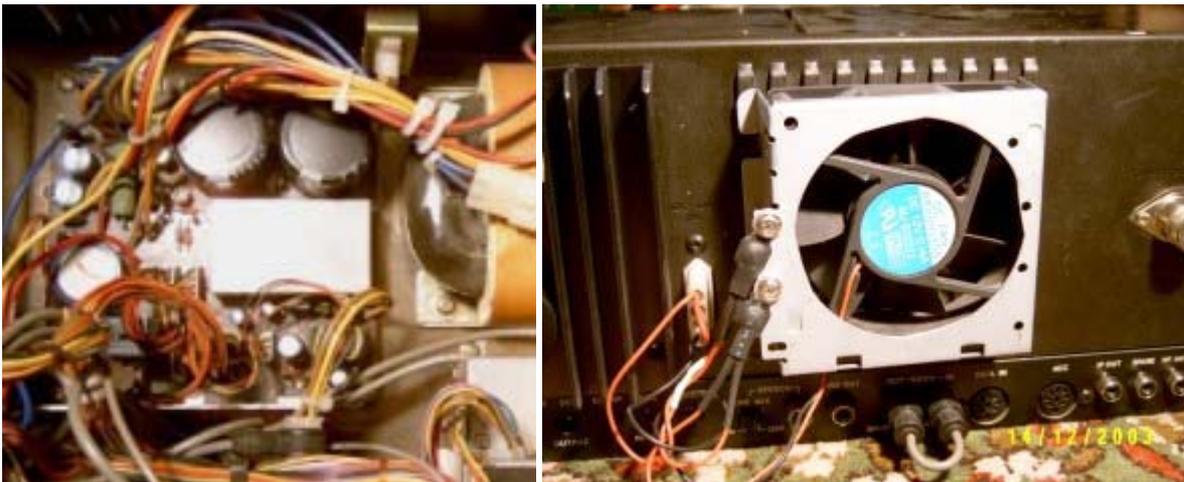
Because of this, and also because of their low quality, the electrolytic capacitors used in the DC-DC converter on the REG PCB board may fail. The usual symptom is no reception along with an abnormal S meter indication. It is caused by an incorrect value of the negative output voltage. C26, C29, C33 and possibly the other caps on the DC-DC converter in the REG Unit may be affected. They have to be replaced. If possible replace all of the converter's electrolytics. Use high quality 105 C ones.

After replacing the capacitors you may add a cooling fan so as to avoid any future problems. I have installed a temperature controlled 3" fan (using two 82 ohm NTC thermistors in series) and its mounting device from an old computer case. The mounting I have found fitted exactly under the back panel fins near the REG Unit. There was not need to run wires inside the radio, nor even to open it; it can use the voltage available at the DC output connector on the back panel. While the airflow is not very high, it is adequate. The cooling improvement is still significant. The interior of the power supply is no longer hot, and the noise is very low as the fan speed is limited by the two NTC's. The fan can be removed in a few seconds if required (e.g. for shipping).

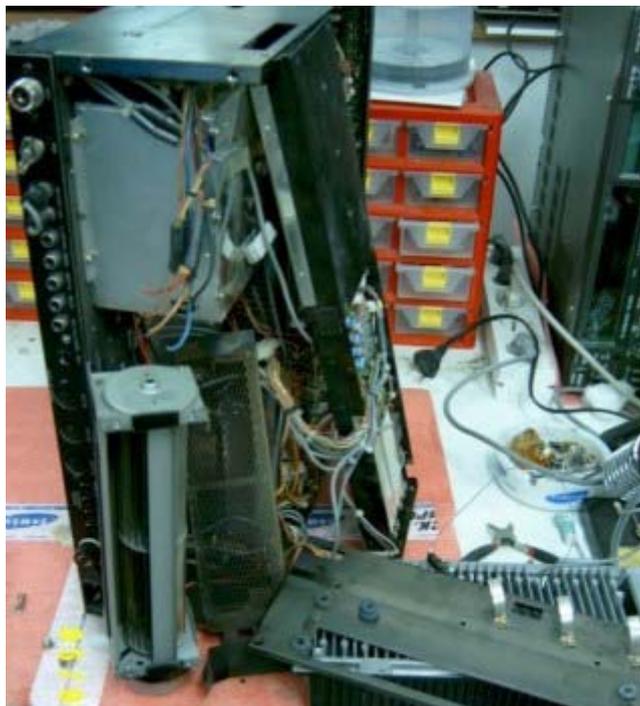
IC-781; heatsink and fan removed;

It is located under the RF/Filter Units module at the rear left side of the radio, and is attached to the big heatsink with screws. This fan may need lubrication. Its motor may have ball bearings (not requiring lubrication) - but the other end of the squirrel cage, at the right side looking from the front, it uses a sleeve bearing. The RF/Filter module has to be removed to gain access to the fan. Putting the radio on its left side may help to apply a small drop of oil to the sleeve bearing using a syringe.

The fan is sitting on its motor side, and the sleeve bearing is at the top part of the fan's case

If the fan and especially its squirrel cage (rotor) are very dirty and dusty, then the fan should be completely removed and dismantled and the rotor cleaned. Clean the heatsink fins as well.
