## Some technical and maintenance issues regarding the IC-781 and IC-R9000

by Traian Belinas, YO9FZS

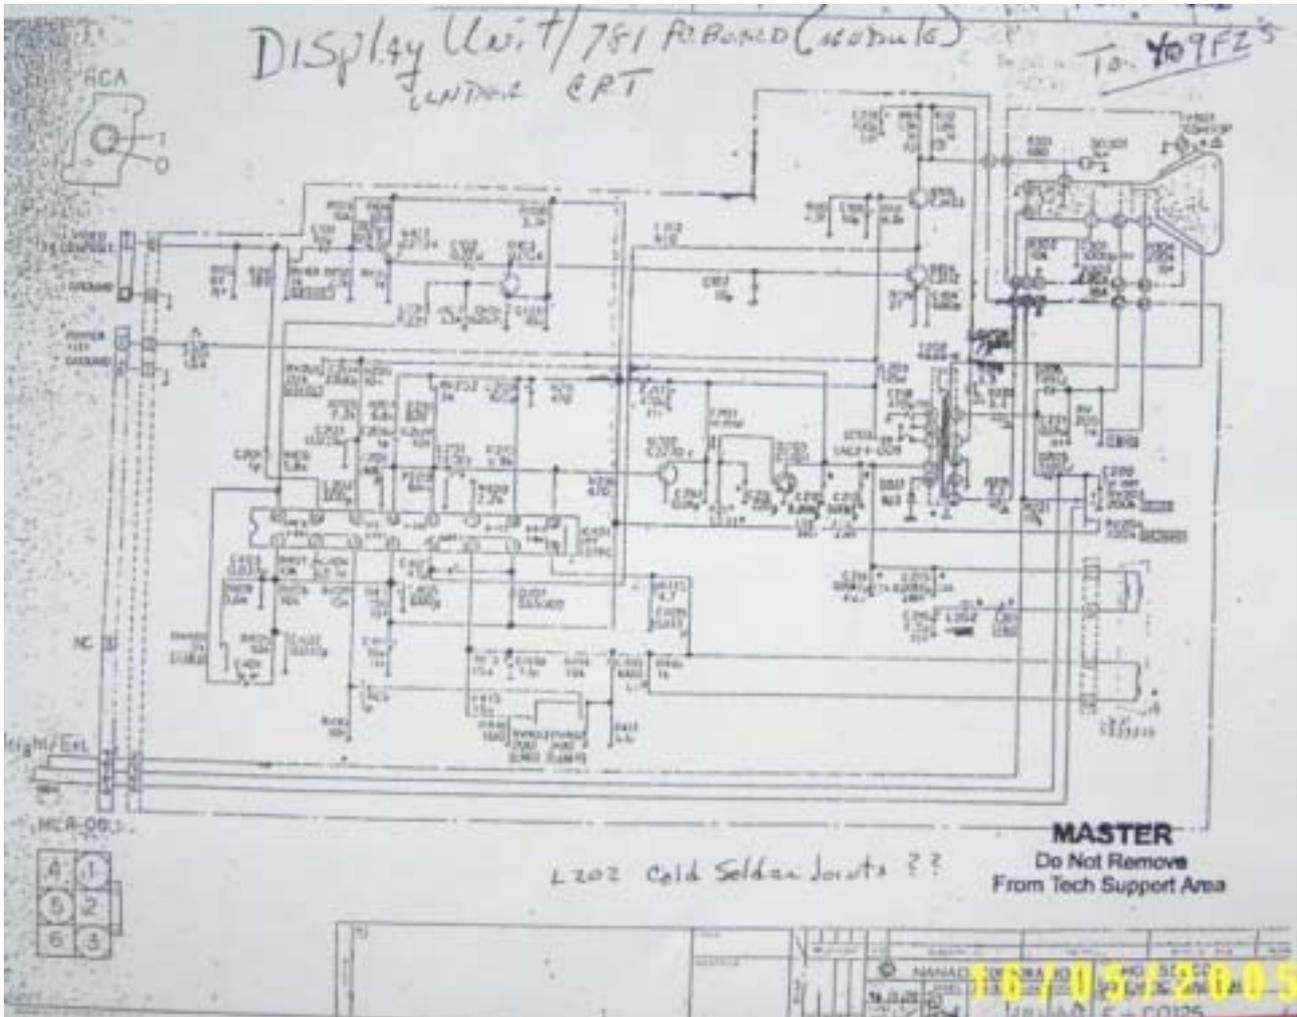
The CRT module diagram is not included in the service manual, but the above is a low-resolution copy which may be of some help (many thanks to K2SB).
